ITW DELTAR FASTENERS — TROY, MI

Old Bolt Holes Try on Some New Threads

Automotive molder ITW Deltar Fasteners found new life for the battered bolt holes on its machine platens with a solution that's designed to last.

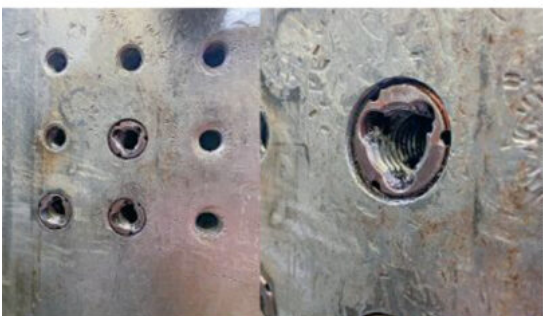
C-Sert threaded inserts help molders replace stripped bolt holes on platens with a new threaded hole that promises long service life.

The C-Serts apply what's known as an interference or metal-to-metal fit, which the company says ensures they will not back out, pull out or vibrate themselves free. Acting as both an insert and a tap, the C-Sert's internal threads are as hard as a tap, making them highly resistant to damage from bolts once installed.

On the advice of his tooling manager, Dearing ordered several C-Sert kits and repaired four badly damaged holes on the Toyo machine in less than 90 minutes. The kits came with a 60-degree center; a cutting bit to open the stripped hole; cutting oil for the cutting bit; the threaded C-Serts; and a bit to install the inserts into the platen. ITW Deltar Fasteners used its own mag drill to center on the hole and perform the cutting.
